## Post-fire soil hydrology, water erosion and restoration strategies in Andosols: a review of evidence from the Canary Islands (Spain)

Andosols are the most characteristic soils of volcanic regions such as the forested, fire-prone, hillslopes of the mountainous Canary Islands (Spain). Due to their volcanic nature, these soils have traditionally been considered highly resistant to water erosion processes in undisturbed conditions, but are also highly susceptible to environmental disturbances. In addition, volcanic terrains often underlie heavily-populated, steep areas where torrential rains are frequent, increasing the threat to the population and infrastructures down-slope. Numerous hydrological and erosional catastrophic events in disturbed Andosols in the Canary Islands and worldwide, leading to major losses to lives and properties, have been historically and recently reported. The impact of environmental alterations such as land use change on hydrological and erosional response of Andosols has been widely studied in the Canary Islands and worldwide. However, the effect on this soil type of wildfires, generally considered one of the main geomorphological agents, and historicall

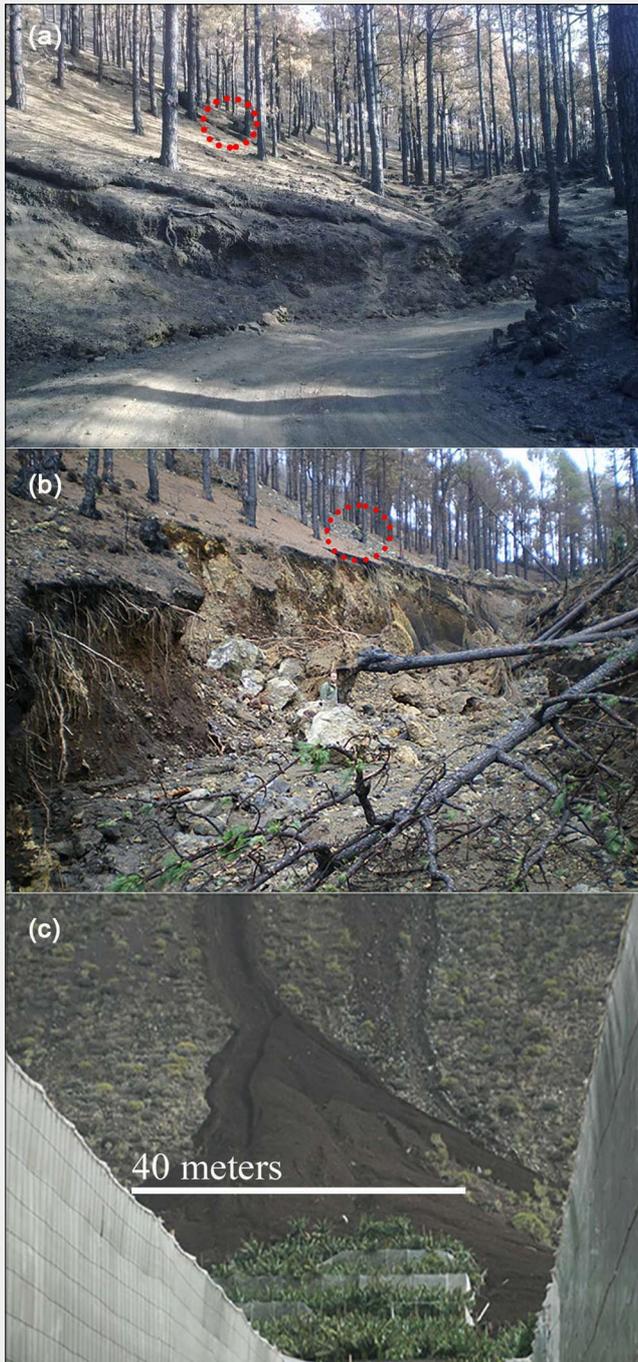
**Fig. 2** - Landslides after the forest fire in La Palma (2009). Forest road before (a) and after (b) the torrential rains and subsequent landslides in 2009. Sediment deposition after the landslide affecting banana crops near the southern coastline of La Palma (c).

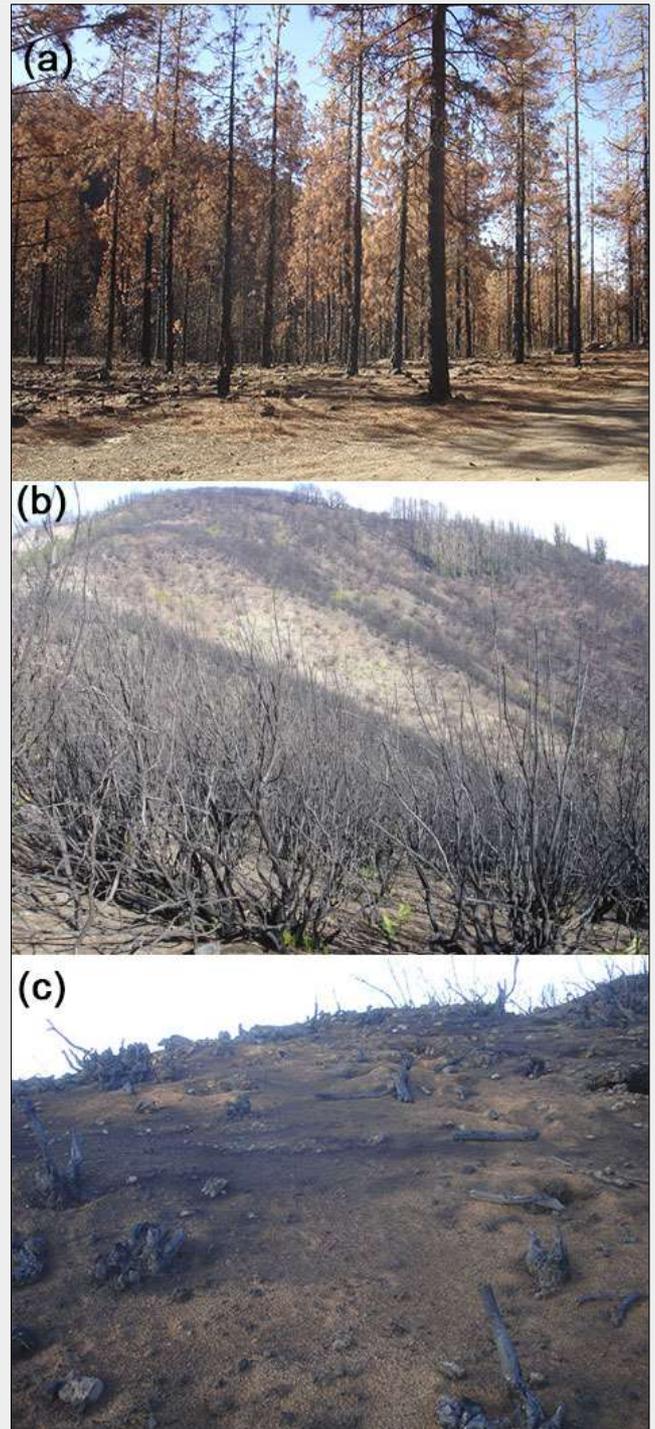
**Fig. 3** - Examples of forest fires in the Canary Islands. Low (a), moderate (b) and high severity (c) according to the fire severity classification by Ryan (2002).

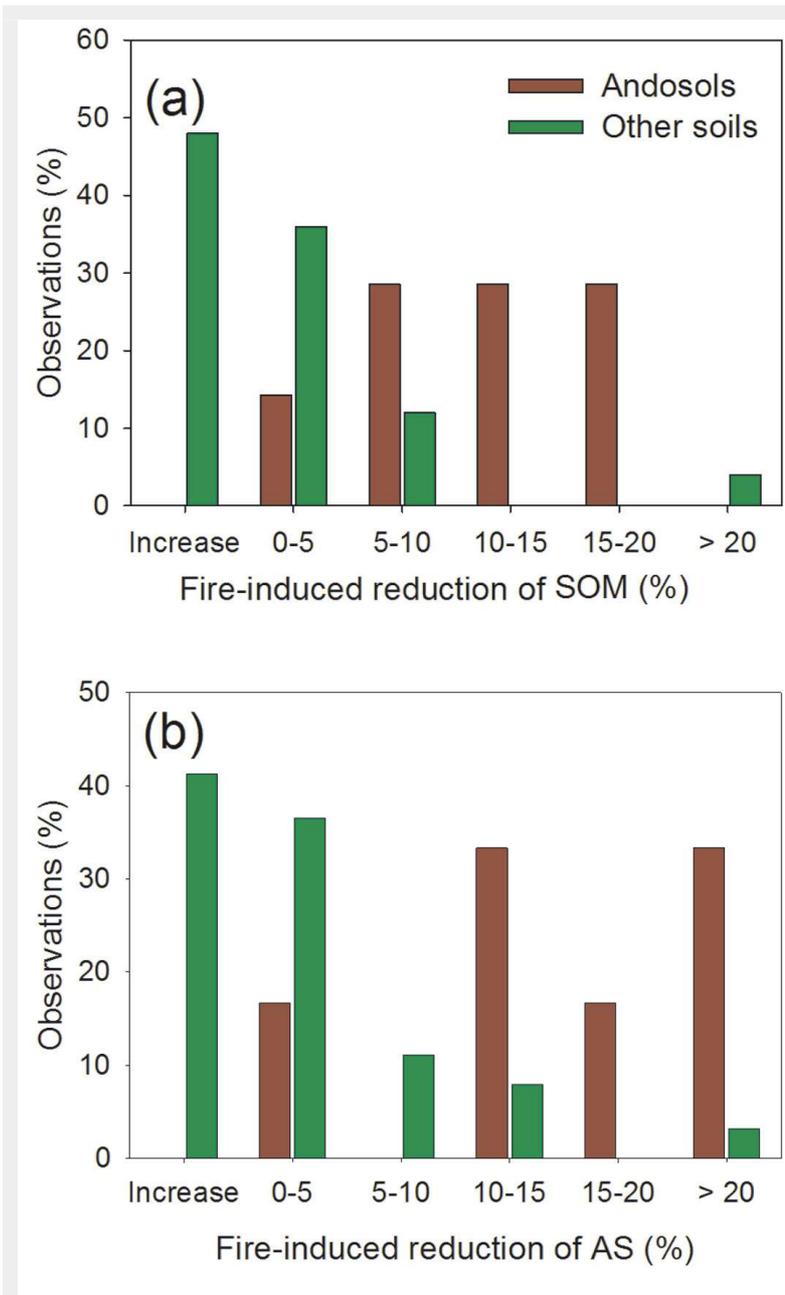
**Fig. 4** - Comparison of the impact of fire on key soil properties in Andosols (red) and other soil types (green). Distribution of results reporting fire-induced reduction/increase in (a) soil organic matter (SOM: %) and (b) aggregate stability (AS: %) for Andosols (N = 7 for SOM and N = 6 for AS) and other soil types (N = 25 for SOM and N = 63 for AS) from published data. Values calculated as Unburned value minus Burned value. Data source: Andosols (De La Rosa et al. 2013, Morales et al. 2013, Neris et al. 2013b); other soil types (González-Pérez et al. 2004, Marcos et al. 2007, O’Dea 2007, Campo et al. 2008, Terefe et al. 2008, Are et al. 2009, Varela et al. 2010, Certini et al. 2011, Mataix-Solera et al. 2011, Badia-Villas et al. 2014).

Fire affects several properties of Andosols that are relevant to their hydrological and erosional responses. Andosols have shown a substantial decrease of aggregate stability (AS) after wildfire both in Canary Islands (Neris et al. 2013a) and South America (Morales et al. 2013), which can reduce their infiltration capacity and enhance erosional processes. Data published by the above authors shows that AS figures decreased more than 15% in half of the fire-affected Andosols studied, whereas 30% of those Andosols showed a decrease of AS exceeding 20% (Fig. 4b). In contrast, the decrease in AS after fire reported for other soil types rarely exceeded 15% (Marcos et

al. 2007, O'Dea 2007, Campo et al. 2008, Terefe et al. 2008, Are et al. 2009, Varela et al. 2010, Mataix-Solera et al. 2011, Badia-Villas et al. 2014 – Fig. 4b). According to Mataix-Solera et al. (2011) this is the typical response of soils such as Andosols, whose main binding agent is SOM (Candan & Broquen 2009). As reported by several authors (De La Rosa et al. 2013, Morales et al. 2013, Neris et al. 2013a, 2014), Andosols' SOM can be severely reduced and its chemical composition altered by fire. According to the aforementioned authors, fire-induced SOM reduction ranges from 20 to 4 g 100 g<sup>-1</sup> and > 50% of the fire-affected soils evaluated showed a decrease in excess of 10 g 100 g<sup>-1</sup> (Fig. 4a). Contrastingly, the reduction of SOM in non-volcanic soils rarely exceeds 5 g 100 g<sup>-1</sup> (González-Pérez et al. 2004, Varela et al. 2010, Certini et al. 2011 – Fig. 4a). Additionally, several authors have reported a significant decrease in AS and the alteration of soil porosity of volcanic soils under severe drying processes (Buytaert et al. 2002, Woignier et al. 2008, Dorner et al. 2010). The combined impact of fire on both SOM and soil mineralogy could explain the considerably high reduction of AS exhibited by Andosols.

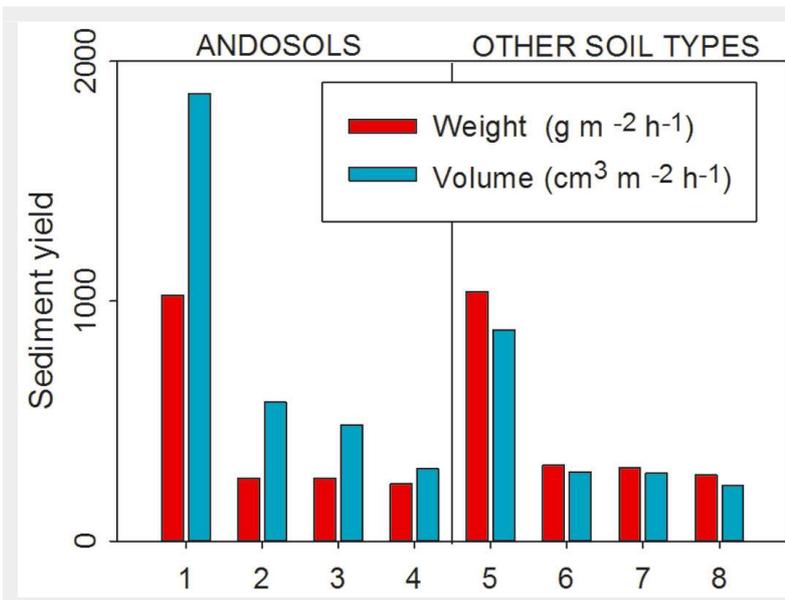
**Fig. 5** - Comparison of post-fire sediment yields in Andosols and other soil types reported using rainfall simulations. Yield measured in weight (red) and volume (blue) for Andosols (left) and other soil types (right). Data source: (1): Morales et al. 2013; (2): Neris et al. 2013a; (3): Neris et al. 2013b; (4): Poulenard et al. 2001; (5): Woods & Balfour 2008; (6): Pierson et al. 2009; (7) Cerdà & Doerr 2008; (8): Woods & Balfour 2008.

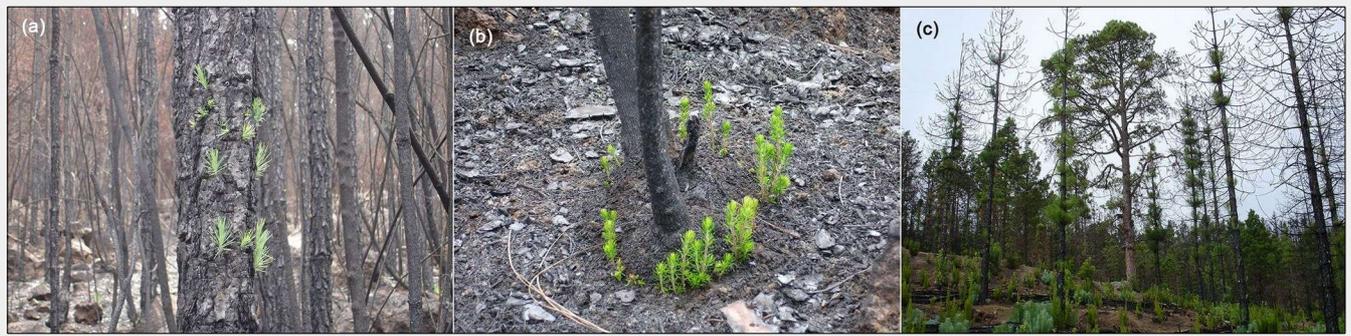
**Fig. 6** - Examples of sprouting behavior of forest species after a wildfire. *Pinus canariensis* (a) and *Erica* sp. (b) sprouting 3 months after the forest fire. Forest recovery 1 year after the forest fire (c).

in forested areas that experience frequent fires (Fig. 6). *Pinus canariensis*, the endemic pine species in the Canary Islands, shows several fire adaptations including thick bark and buds, long needles, tall growth habit and sprouting capacity (Climent et al. 2004). Additionally, one of the main genus present in the Canarian rainforest, *Erica*, also exhibits high sprouting capacity after fire (Lloret & Vila 2003). According to the aforementioned agencies, the fast recovery after fire makes reforestation unnecessary. Instead, silvicultural practices on the affected area are carried out, including the removal of dead individuals and the pruning of charred branches of surviving trees to reduce infestation threats and strengthen their recovery (Fig. 7). However, recent observations after a forest fire that affected La Gomera in 2012 suggest that these silvicultural practices could delay vegetation recovery after fire. In order to

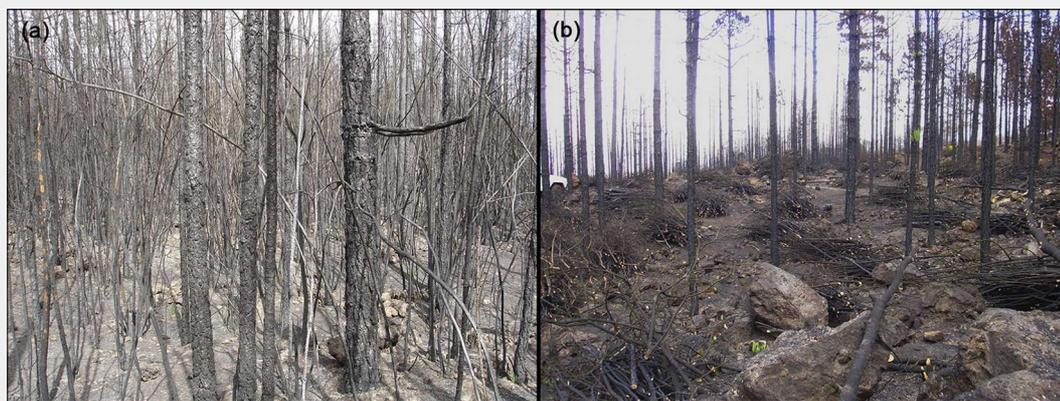
**Fig. 7** - Example of restoration works after the large forest fire of 2007 in Tenerife. Fire-affected forest area before (a) and after (b) silvicultural practices.

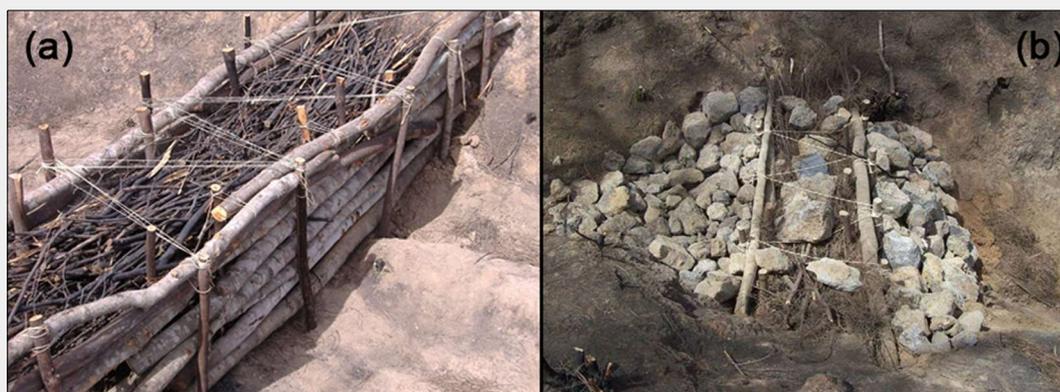
**Fig. 8** - Construction process of the rock and biomass mixed dam. Trench constructed and filled with debris from the silvicultural works (a) and reinforced by rocks (b).

In addition to the traditional channel treatments, an innovative structure adapted to local conditions, called rock and biomass mixed dam, was developed after a forest fire in Tenerife that burned 17 000 ha in the summer of 2007 (Ministerio de Medio Ambiente y Medio Rural y Marino 2008). Due to the magnitude of the wildfire and the resulting risks, the structure was designed to be low-cost, easy and rapid to be implemented to reduce hydrological risks. The mixed dam is a temporary structure that combines different mitigation techniques such as contour logs, contour trenches and rock dams. Similarly to other channel treatments, its main objective is to reduce water velocity and enhance infiltration and sediment deposition. The mixed dam consists of vegetal debris used as vertical stakes (mainly burned logs

of *Erica* sp. and *Myrica faya*) and horizontal logs (mainly from burned *Pinus canariensis*) and biodegradable rope to tie the stakes and logs together as a trench and to anchor the whole structure to adjacent trees. The trench is reinforced on the outside by the rock slope to gain stability (less than 50% slope angle) and filled on the inside with vegetal debris obtained from silvicultural work and topped again with rocks (Fig. 8). Its dimensions vary depending on the channel width, although always ranging from 1 to 2 m in height and 8 to 10 m in width. A prediction of the maximum water flow and water level expected in the post-fire period are essential to design these structures. Additionally, the rock density, the resistance to flexion of the wood stakes and logs, the resistance reduction coefficients and the load increase coefficients for both permanent (structure weight) and temporary loads

(water flow) are taken into account in their design. The distance between these structures in a channel is determined according to the structures' height and the channel slope angle (Tardío Cerrillo & Caballero Serrano 2009).

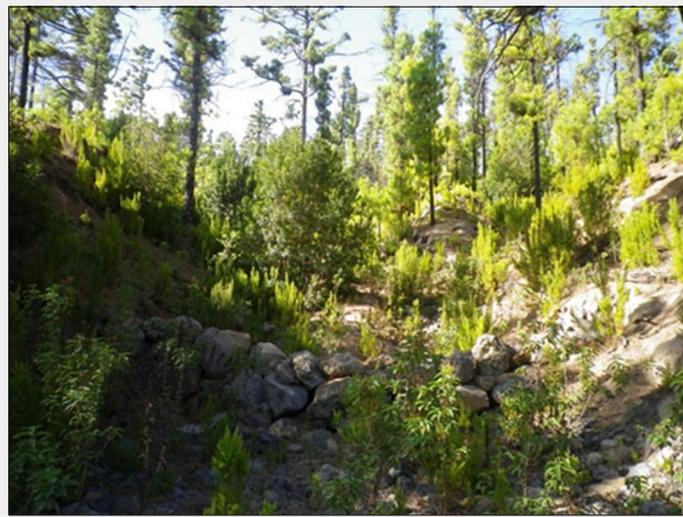
**Fig. 9** - A mixed dam structure built in Tenerife after the large wildfire of 2007, colonized by forest species one year after its construction.

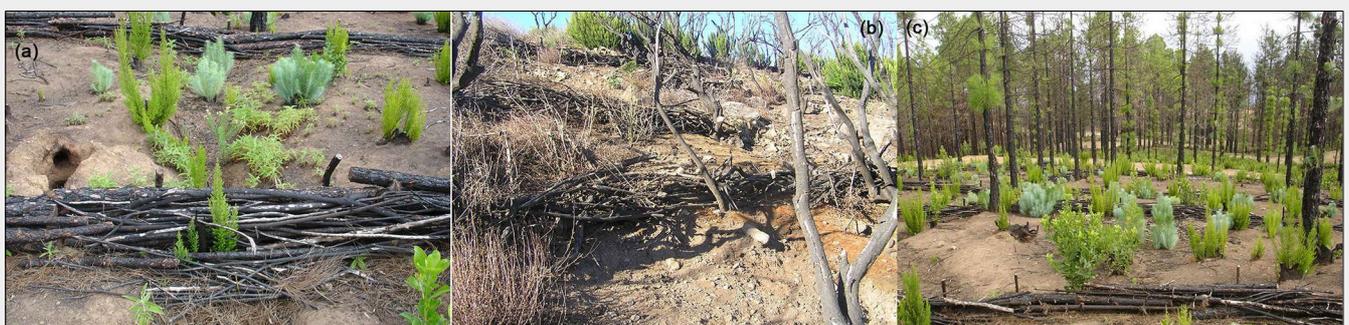
**Fig. 10** - Example of surface treatments after the large wildfire of 2007 in Tenerife. Small dams built using on-hand logs and branches.
